JFK ASSASSINATION SYSTEM

TITLE :
ANALYSIS OF FIREARMS, VEHICLE, ETC.

DATE : 11/23/63
PAGES : 26

DC — Secret Ser. Gar Lincoln Presid. limousine 1:30 AM 11/27/

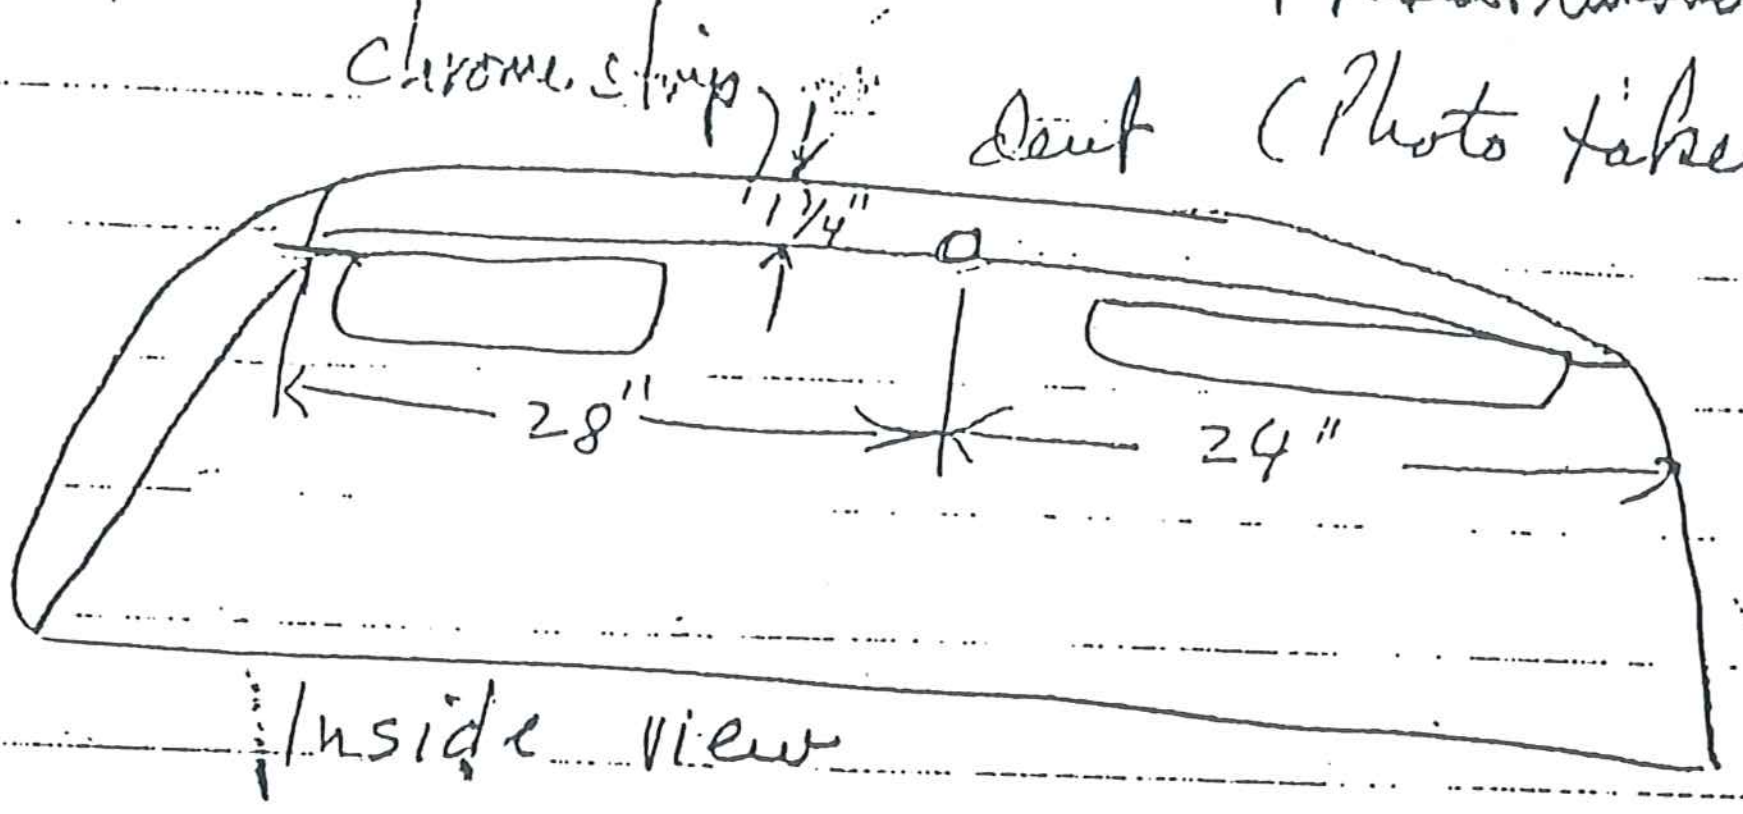
chrome strip
1 1/4"
28"
24"
Inside view

dent (Photo taken)

No direction indicated

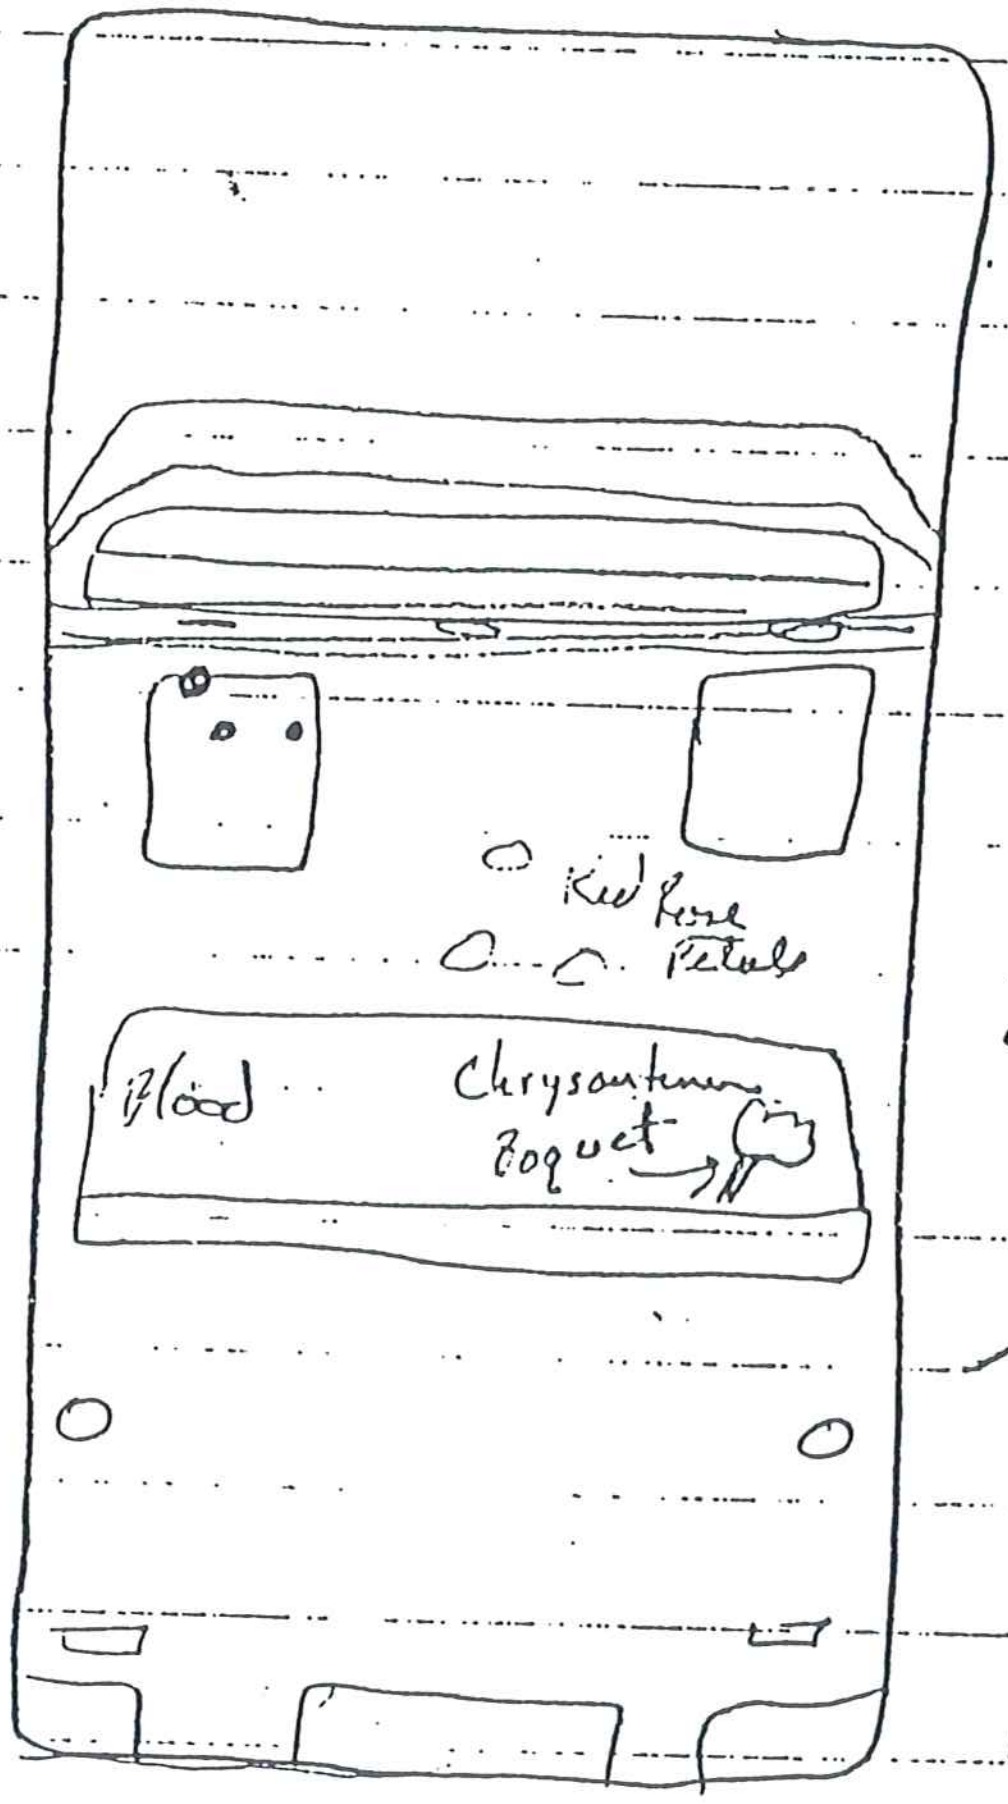
Red Rose Petals
Blood
Chrysantemum Boquet

Blood, tissue or bone Frag. scattered over interior of car and on hood — on visors (both sides of rt visor)

3 Frag. lead found on rear floorboard, 2 on rug, 1 in seat hinge channel (Jump Seat

No other frag. found in car
No bullet holes found

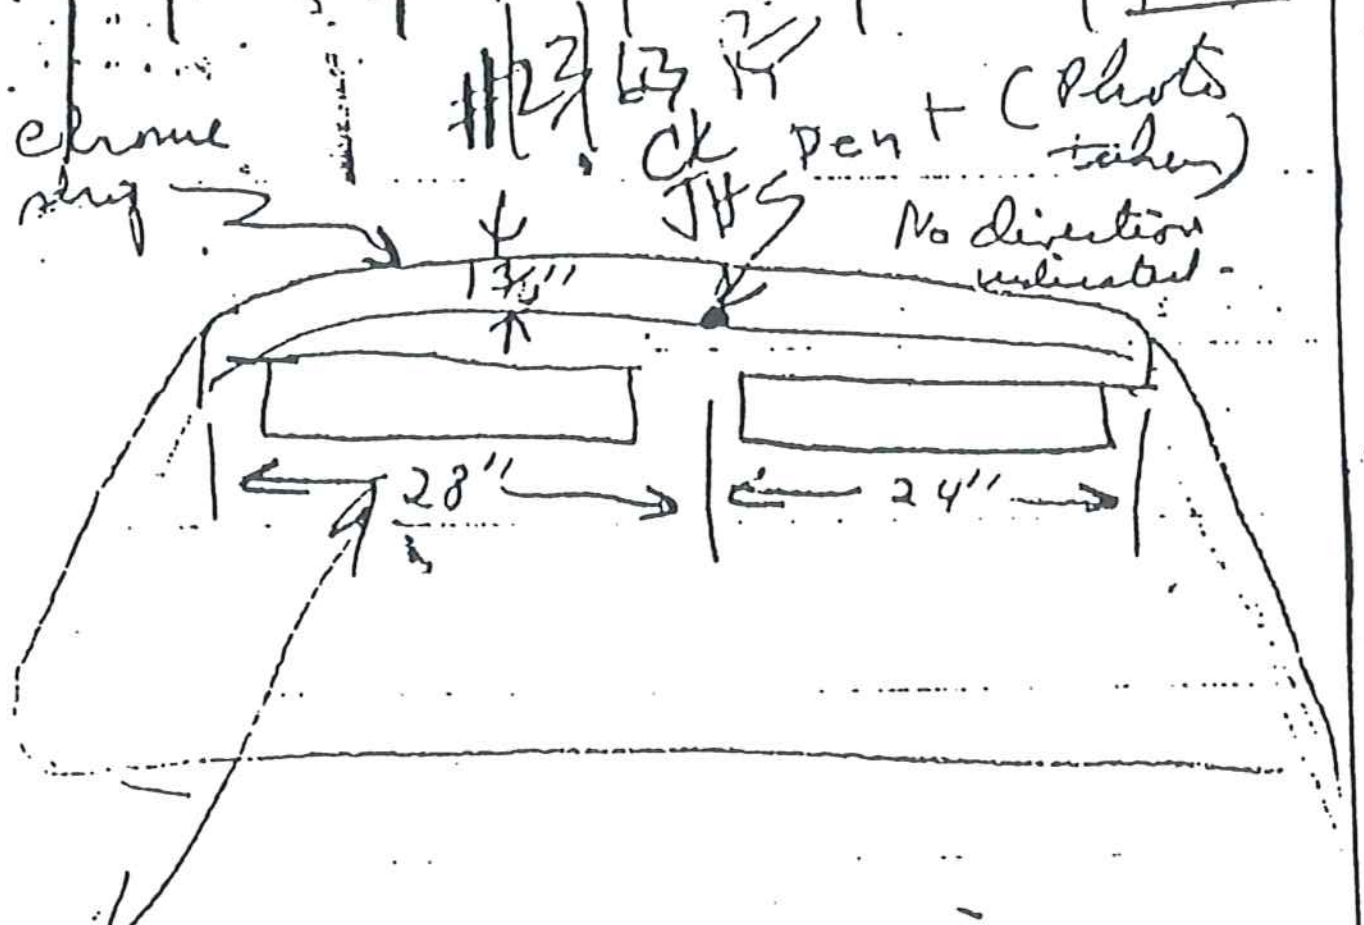
#1223 14
chrome strip
1 3/8"
CK Dent (Photo taken)
JHS
No direction indicated -
28"
24"

Inside view windshield

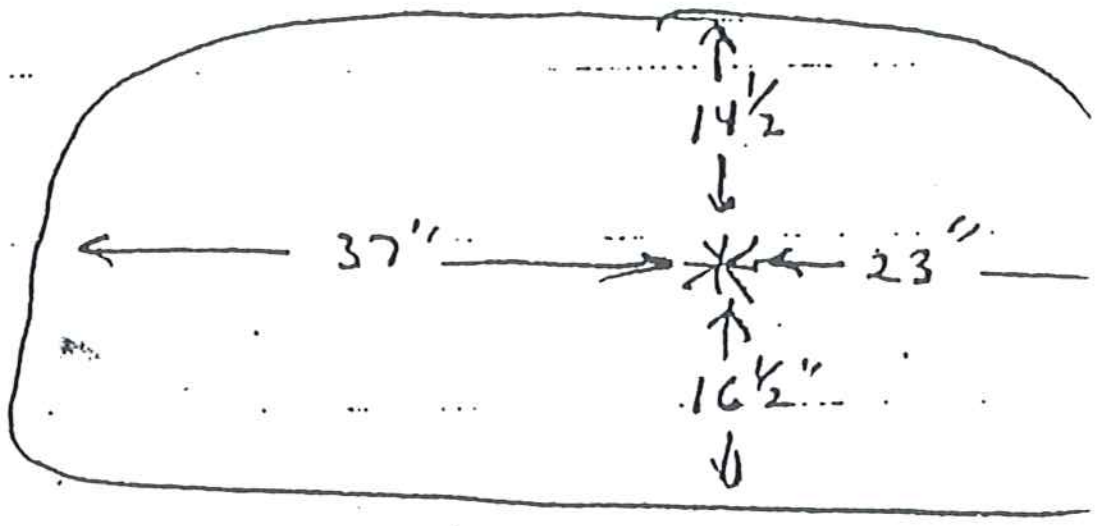
sun visors

14 1/2
37"
23"
16 1/2"

outside view

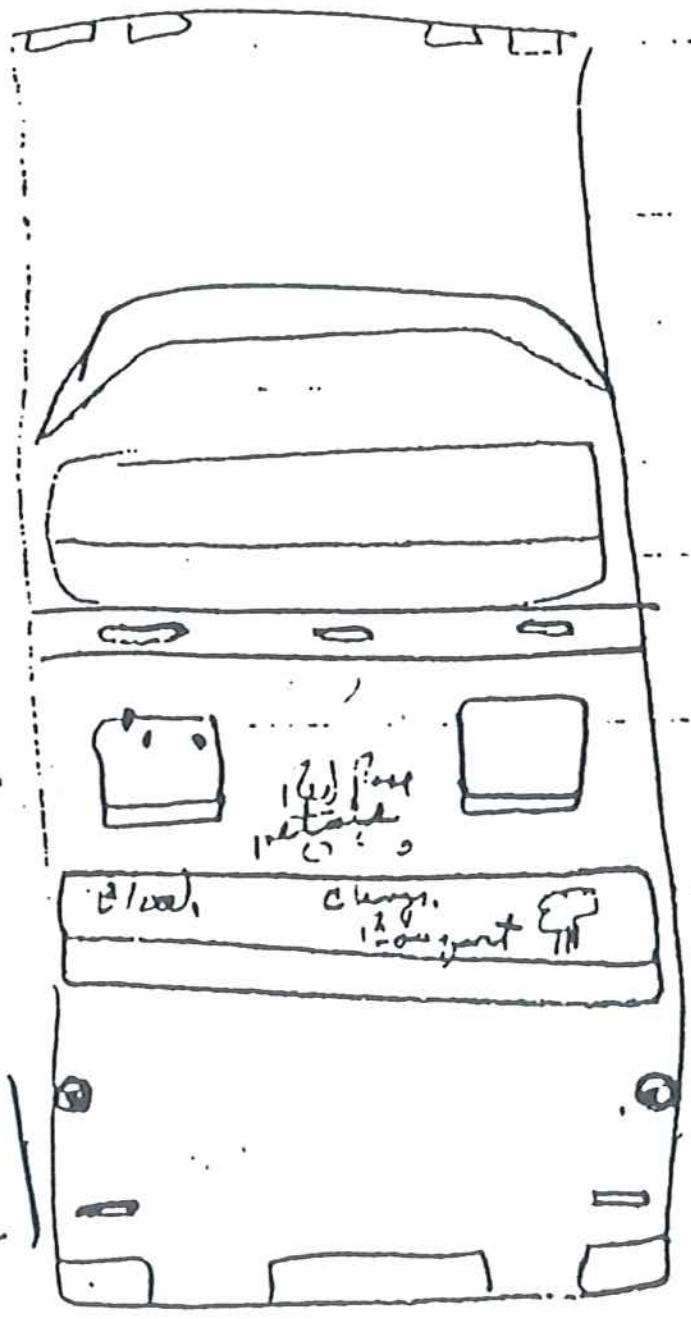
Blood,
Chunks
1 ½ one part

Blood, tissue or Bone frag. scattered over interior of car & on hood - on visors (both sides of Rt visor

3 Frags Lead found on Rear Floorboard. 2 on Rug, 1 in seat's hinge channel (Jumps seat.

No other Frags. found in car,

No bullet holes found Rugs not torn out

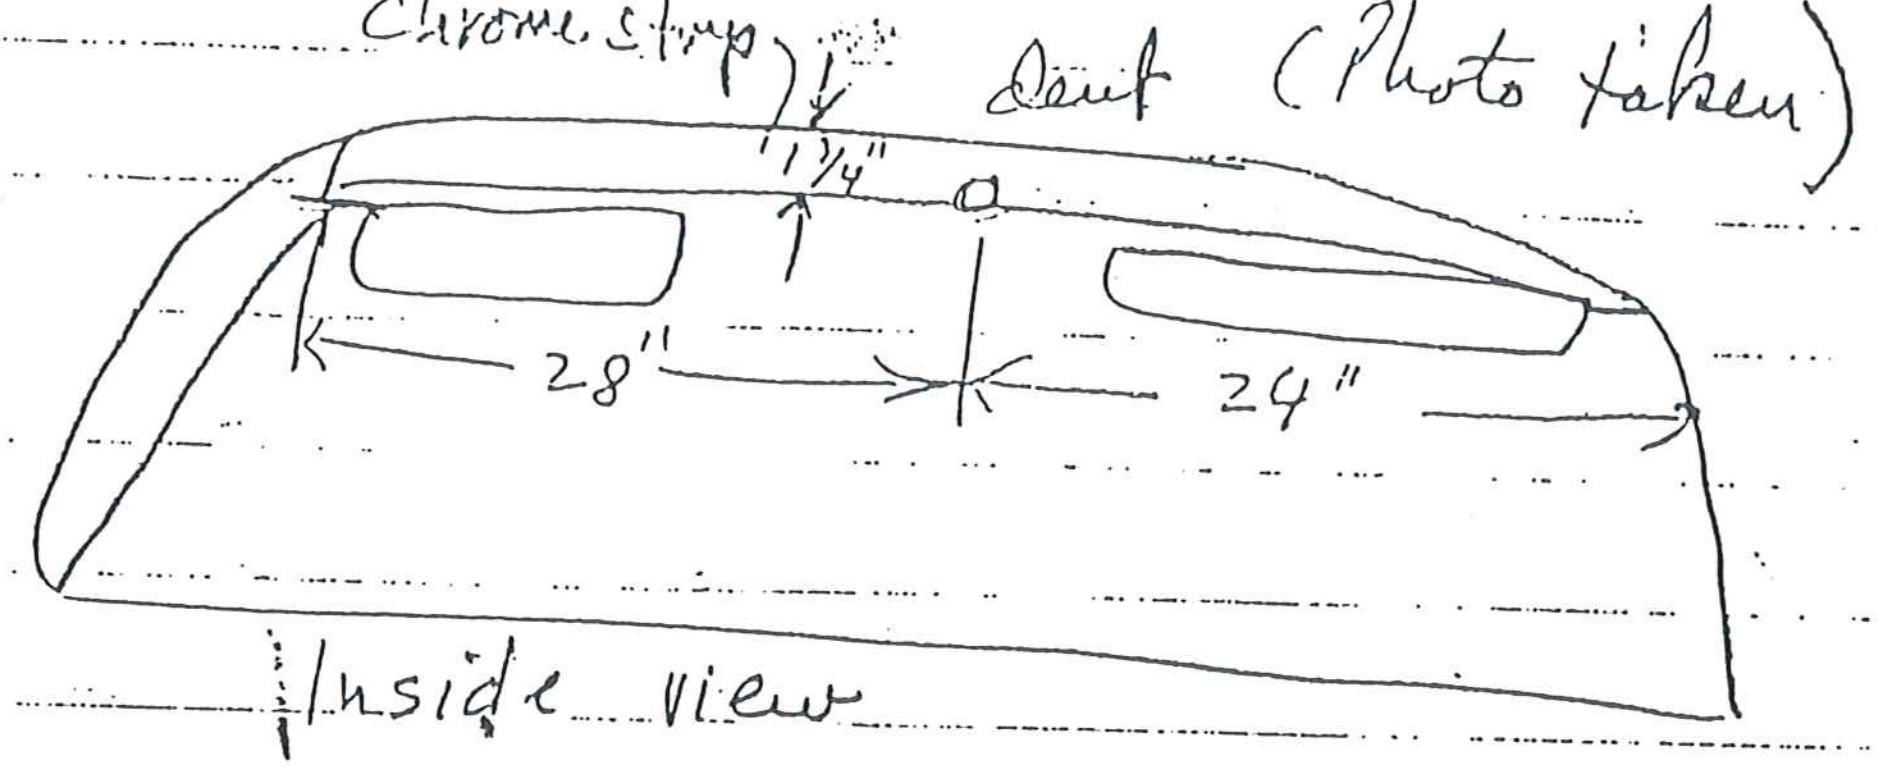
chrome strip
dent (Photo taken)
1 1/4"
28"
24"
Inside view

No direction indicated

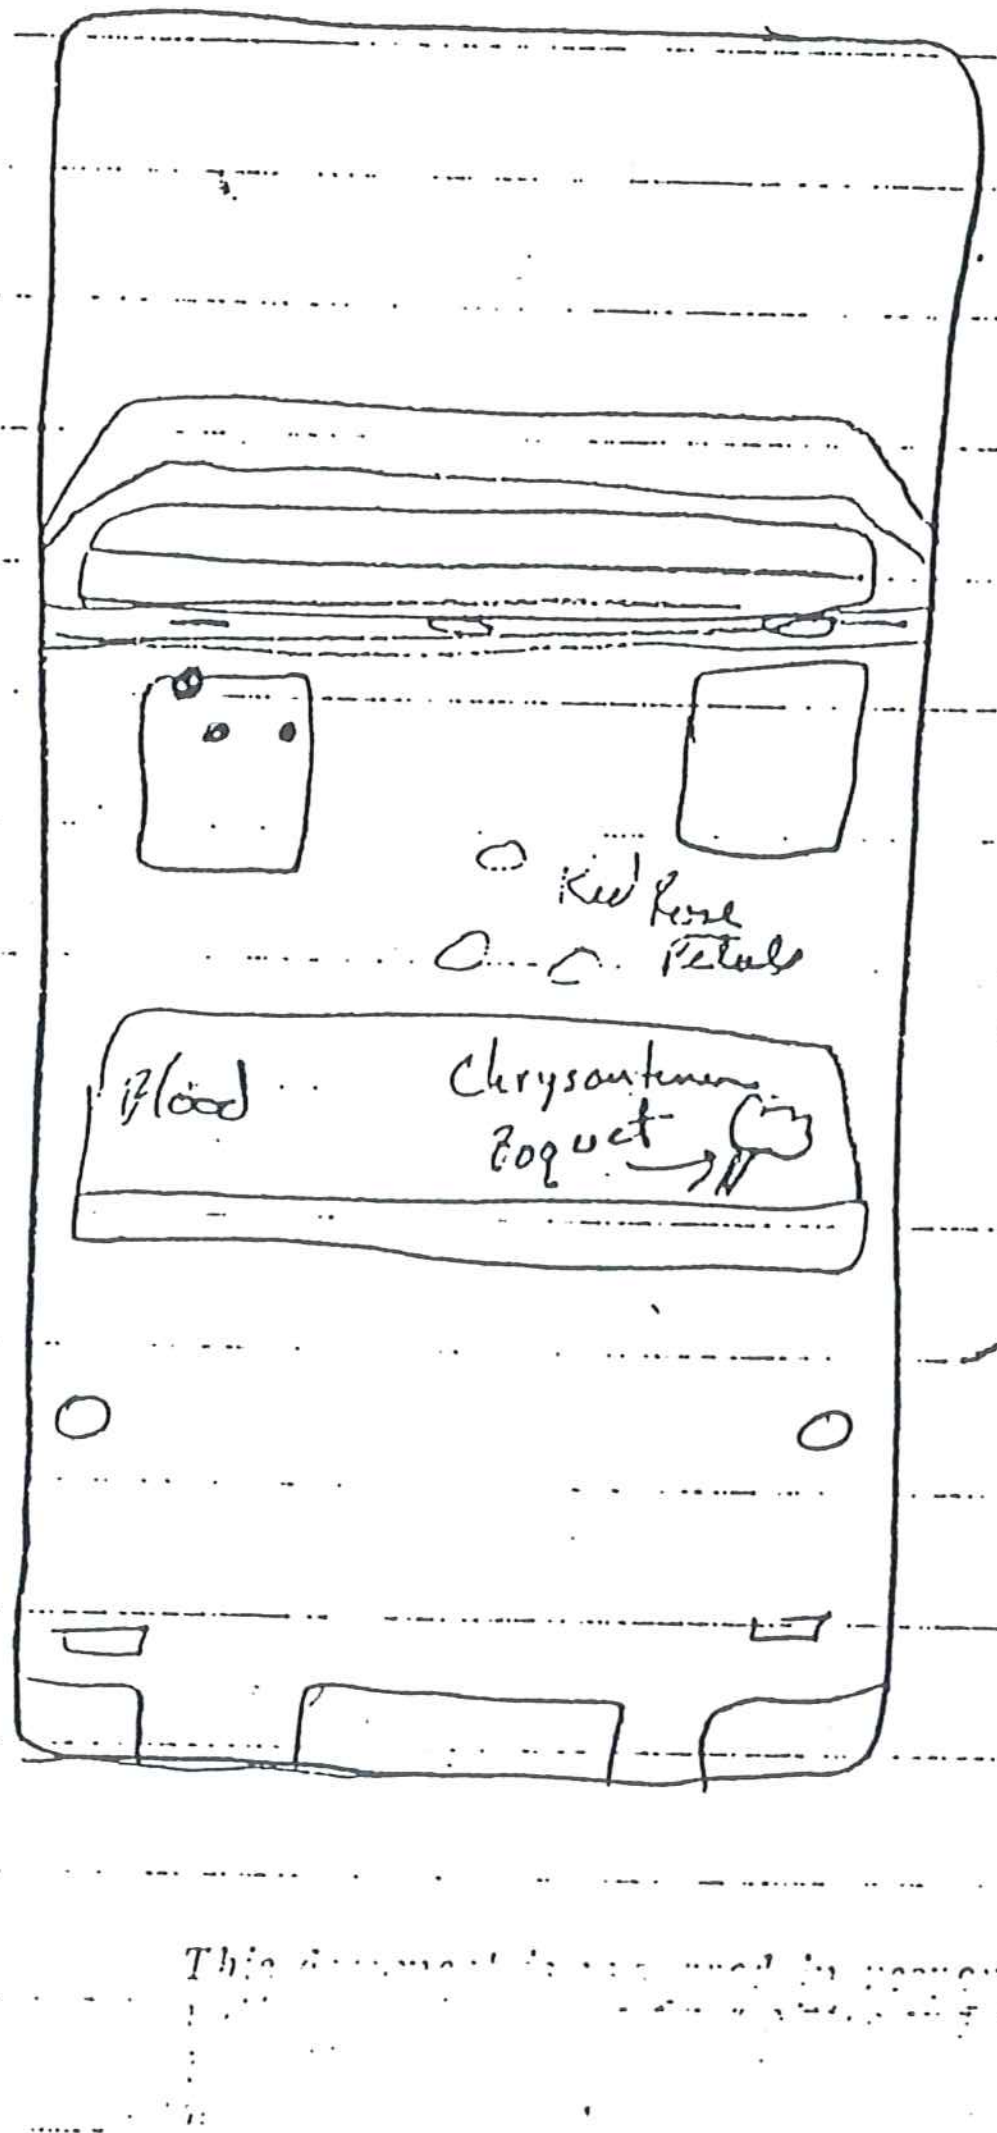
Red Rose Petals
Blood
Chrysantemum Boquet

Blood, tissue or bone Frag. scattered over interior of car and on hood — on visors (both sides of rt visor)

3 Frag. lead found on rear floorboard, 2 on rug, 1 in seat hinge channel (Jump Seat

No other frag. found in car
No bullet holes found

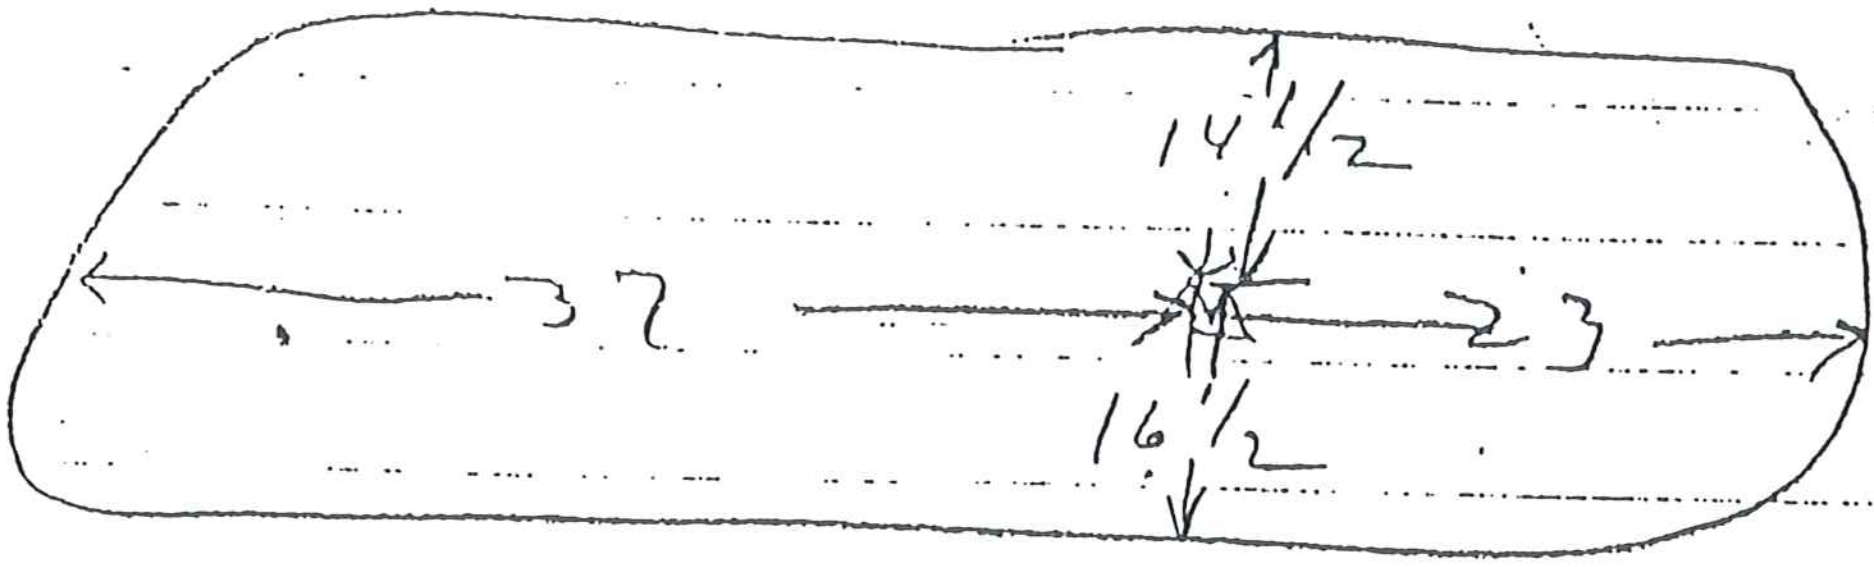
Lincoln limousine 11/23/63

1 Smear resembling lead on inside

2 Cracks on outside - stellate (radiating)

3 Minute frag missing from outside

Struck by projectile on inside surfac
